Subject: Interim Measures Action Summary Letter for The Dow Chemical Company, Hanging Rock Plant, Ironton, OH EPA ID# OHR 000 157 727 and OHD 039 128 913

Hanging Rock Facility - Building 505  
Photolog Interim Mitigation Actions

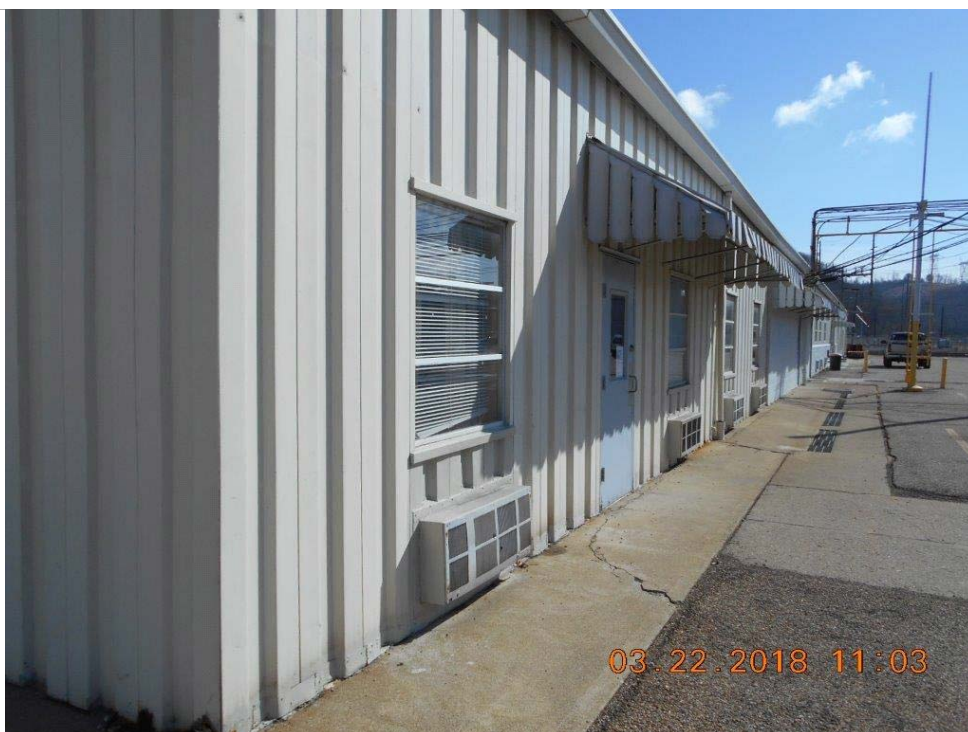
| <b>Photo 22:</b> | HVAC Survey | <b>Date Taken:</b> | 3/22/2018 | <b>View Direction:</b> | East |

| <b>Description:</b> | SW outside building corner showing through-wall air conditioner units | | | | |

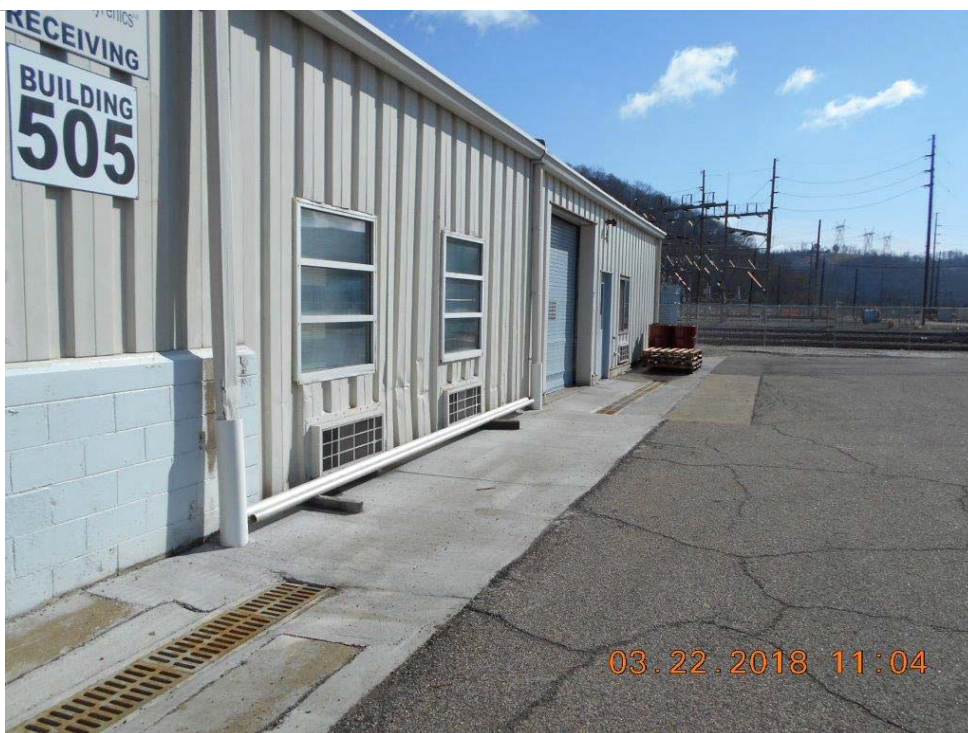
| <b>Photo 23:</b> | HVAC Survey | <b>Date Taken:</b> | 3/22/2018 | <b>View Direction:</b> | East |

| <b>Description:</b> | SE outside building corner, showing through-wall air units, storeroom entry door and garage door, and SE corner breakroom through-wall unit | | | | |

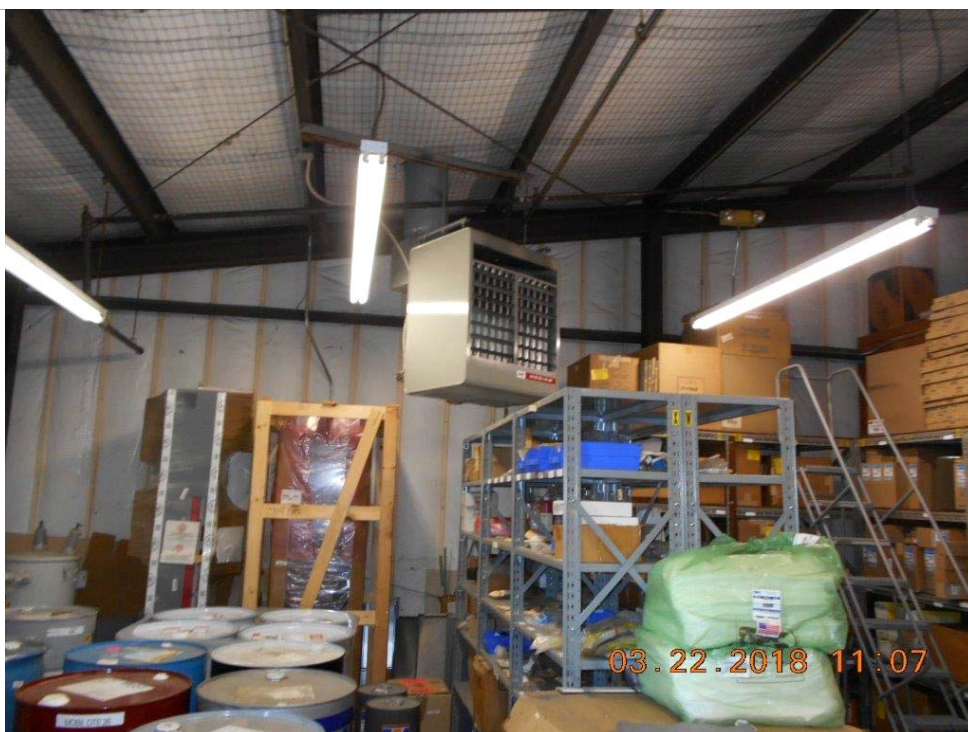
| <b>Photo 24:</b> | HVAC Survey | <b>Date Taken:</b> | 3/22/2018 | <b>View Direction:</b> | West |

| <b>Description:</b> | Gas-fired unit heater in eastern storeroom | | | | |

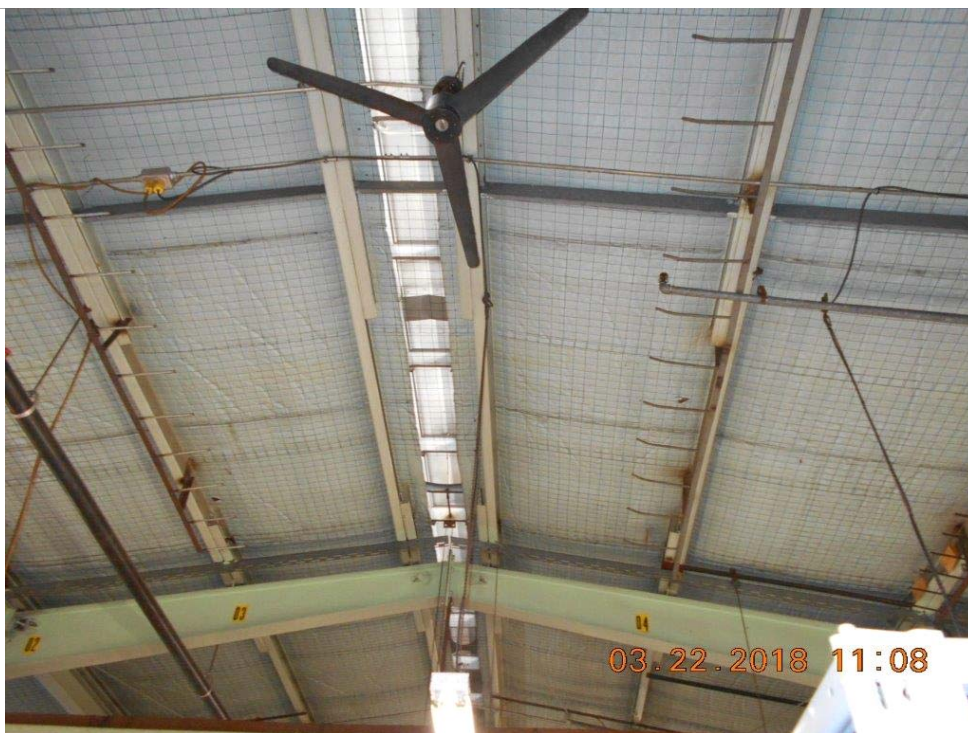
| <b>Photo 25:</b> | HVAC Survey | <b>Date Taken:</b> | 3/22/2018 | <b>View Direction:</b> | West |

| <b>Description:</b> | Ridge vent full length of eastern storeroom | | | | |

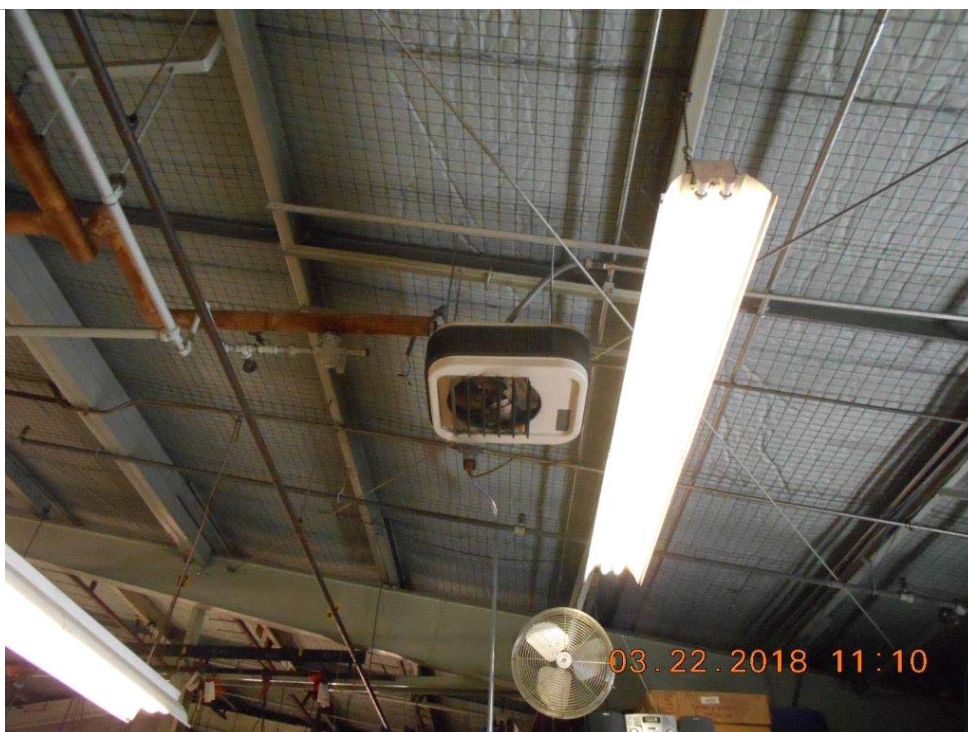
| <b>Photo 26:</b> | HVAC Survey | <b>Date Taken:</b> | 3/22/2018 | <b>View Direction:</b> | West |

| <b>Description:</b> | Electric unit heater in eastern storeroom | | | | |

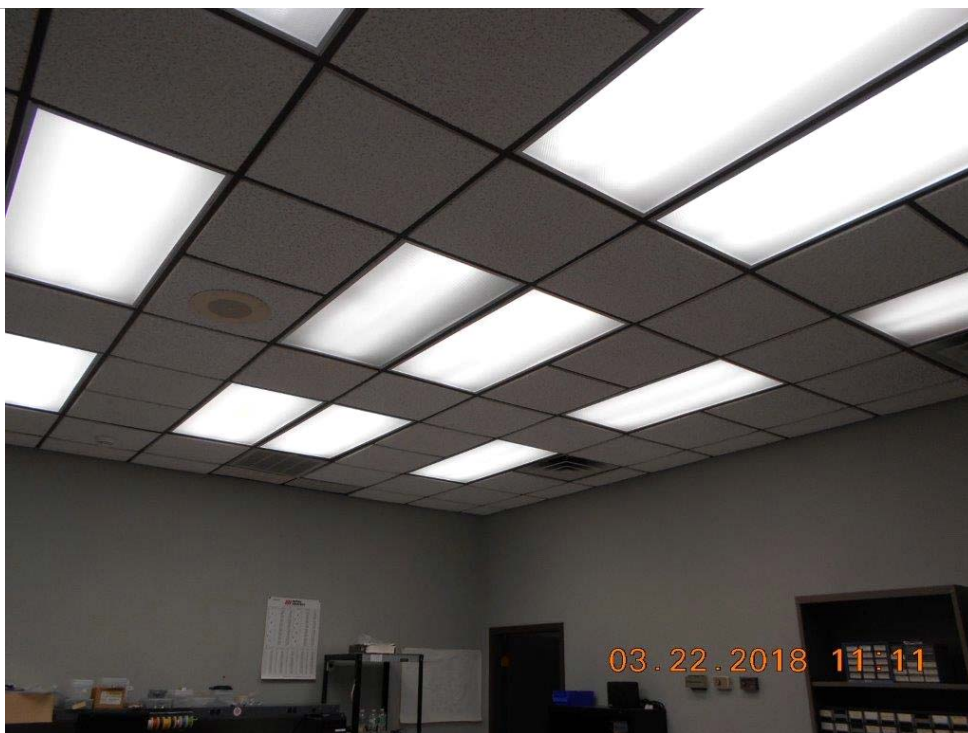
| <b>Photo 27:</b> | HVAC Survey | <b>Date Taken:</b> | 3/22/2018 | <b>View Direction:</b> | Northeast |

| <b>Description:</b> | Central interior computer parts storage room HVAC ceiling arrangement | | | | |

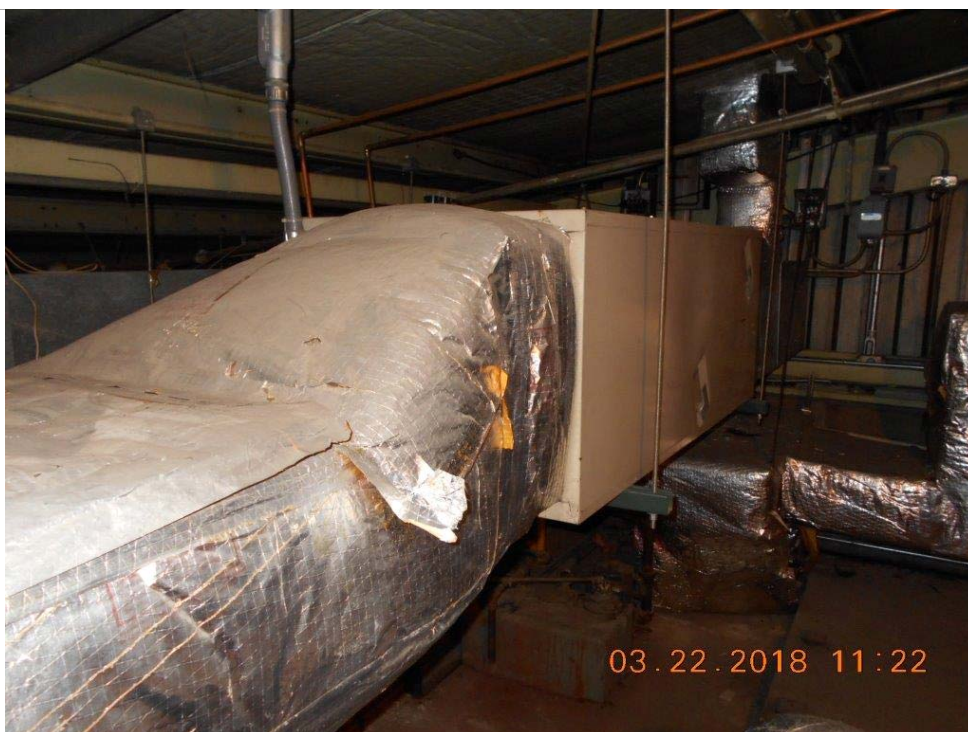
| <b>Photo 30:</b> | HVAC Survey | <b>Date Taken:</b> | 3/22/2018 | <b>View Direction:</b> | West |

| <b>Description:</b> | South Central Exterior Conference 16 split-system heat pump air handler | | | | |

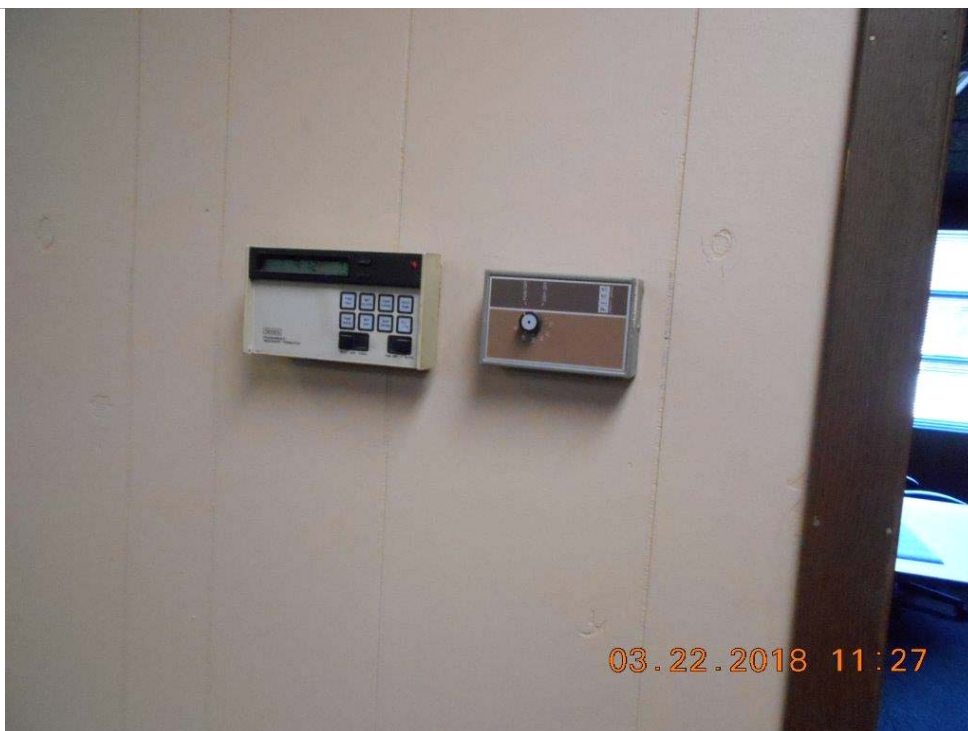
| <b>Photo 31:</b> | HVAC Survey | <b>Date Taken:</b> | 3/22/2018 | <b>View Direction:</b> | North |

| <b>Description:</b> | Wall thermostat and humdistat serving core area | | | | |

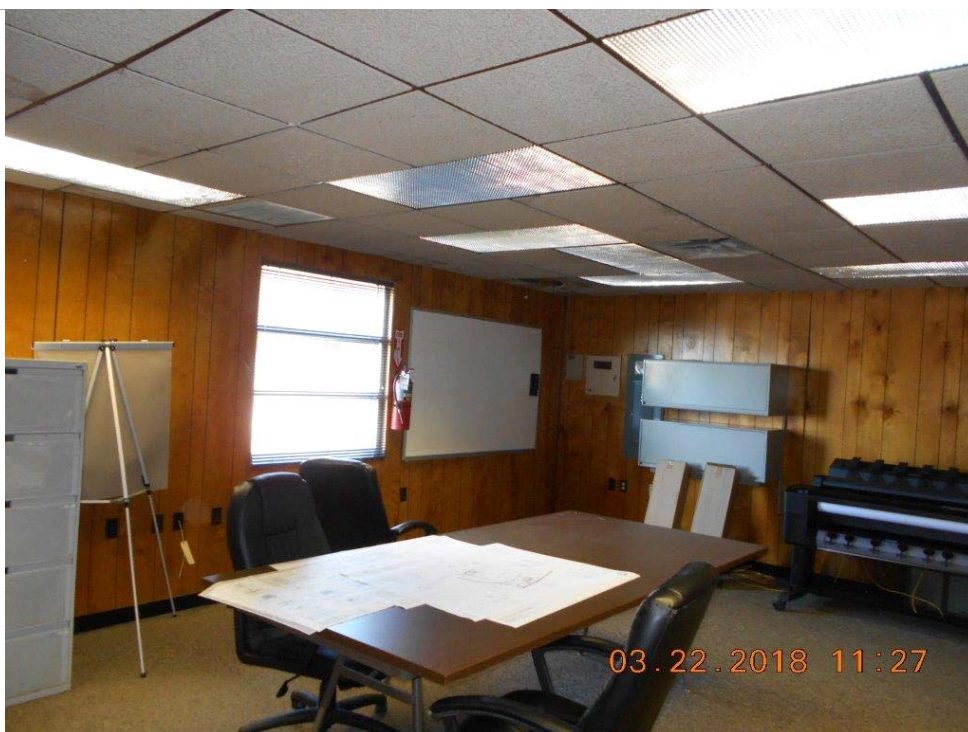
| <b>Photo 32:</b> | HVAC Survey | <b>Date Taken:</b> | 3/22/2018 | <b>View Direction:</b> | Northeast |

| <b>Description:</b> | Northwestern exterior conference room served by split-system heat pump | | | | |

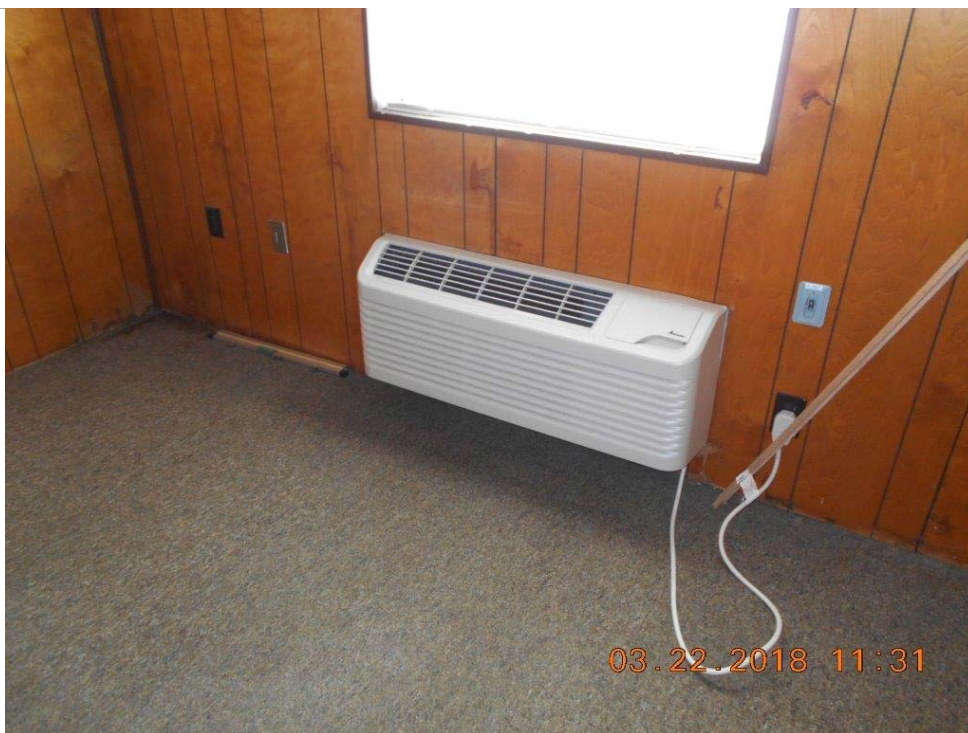
| <b>Photo 33:</b> | HVAC Survey | <b>Date Taken:</b> | 3/22/2018 | <b>View Direction:</b> | West |

| <b>Description:</b> | Through-wall air conditioning unit found in exterior rooms | | | | |

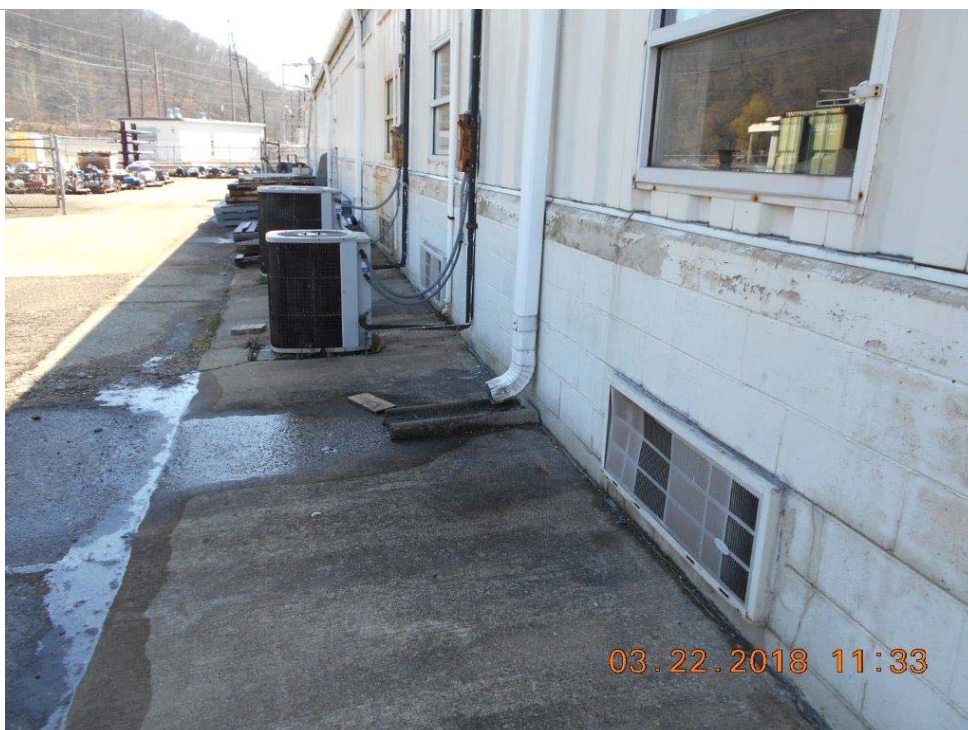
| <b>Photo 34:</b> | HVAC Survey | <b>Date Taken:</b> | 3/22/2018 | <b>View Direction:</b> | East |

| <b>Description:</b> | Split-system outdoor heat pump units, servicing central building section | | | | |

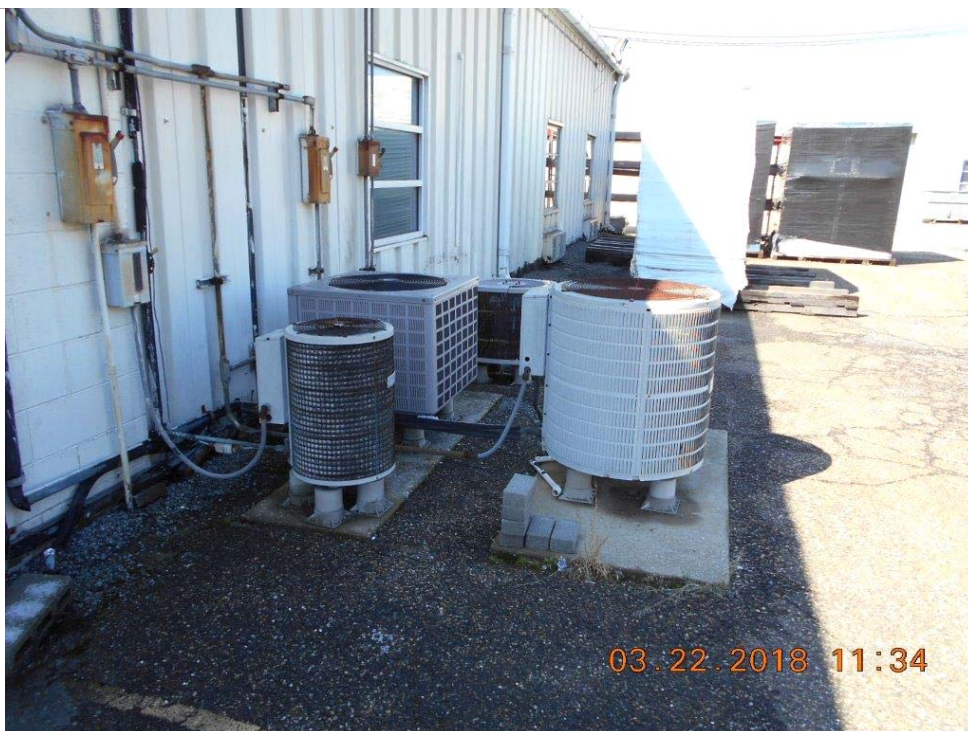
| <b>Photo 35:</b> | HVAC Survey | <b>Date Taken:</b> | 3/22/2018 | <b>View Direction:</b> | West |

| <b>Description:</b> | Split-system outdoor heat pump units servicing western building section | | | | |
